HOPEWELL VILLAGE IRONMASTER'S HOUSE

NATIONAL HISTORIC SITE / PENNSYLVANIA

ARCHEOLOGICAL INVESTIGATIONS
OF THE
IRONMASTER'S HOUSE
HOPEWELL VILLAGE NATIONAL HISTORIC SITE
PENNSYLVANIA

By
Audrey R. Marie

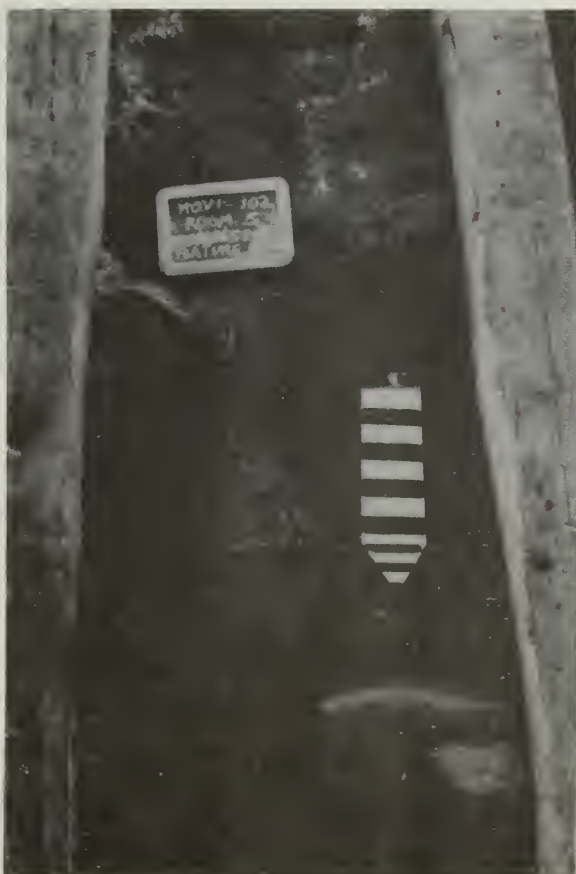
Plate 7

The mortar surface appears to have been excavated for placement of the stone supports beneath the sleepers.

Between the surface loam and the sterile red clay in the kitchen were remnants of a mortar surface (Figs. 5 and 6; Plates 6 and 7). The remaining patches of this surface were deteriorated, fragile, and varied

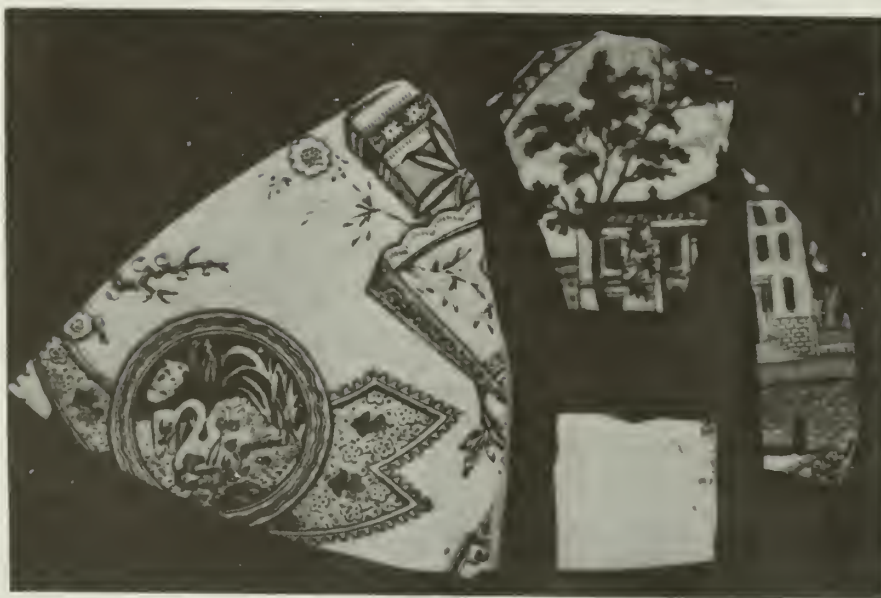
Plate 19

Variety of ceramics from early to late 19th century in Stratum A: Japanese motif on stone china manufactured from 1842 to 1914; Ridgeway Beauties of America, Philadelphia Library, manufactured c. 1814 to 1830; Ridgeway Beauties of America, Boston Athenaeum, manufactured c. 1814 to 1830; stone china, maker's mark indicates manufacture after 1893. Sherds are shown half actual size.

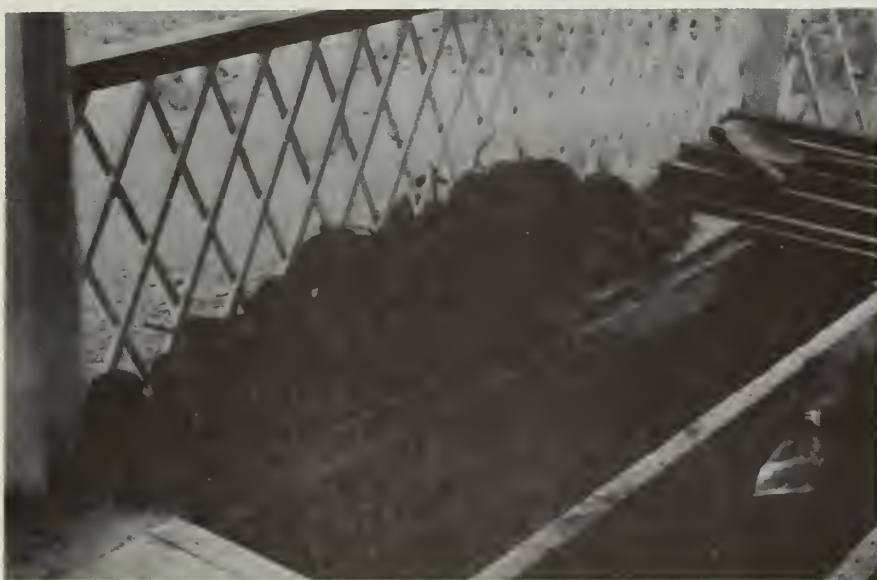
Plate 23

Some of the 8 to 10 inch diameter rocks removed from first 18 inches beneath N15E5 and 10 and N20E5 and 10.

Below the first 2" to 4" of soil, to a depth of 18" below the surface, gravelly red clay and many randomly dispersed 8" to 10" diameter rocks were removed (Plate 23; Fig. 7). Some isolated occurrences of humic brown soil were noted during the excavation of the first 24". However, these proved to be associated with sycamore roots which had grown through the deposit. Much of unit N20E10 was also disturbed by a large animal burrow which tunneled through this area.

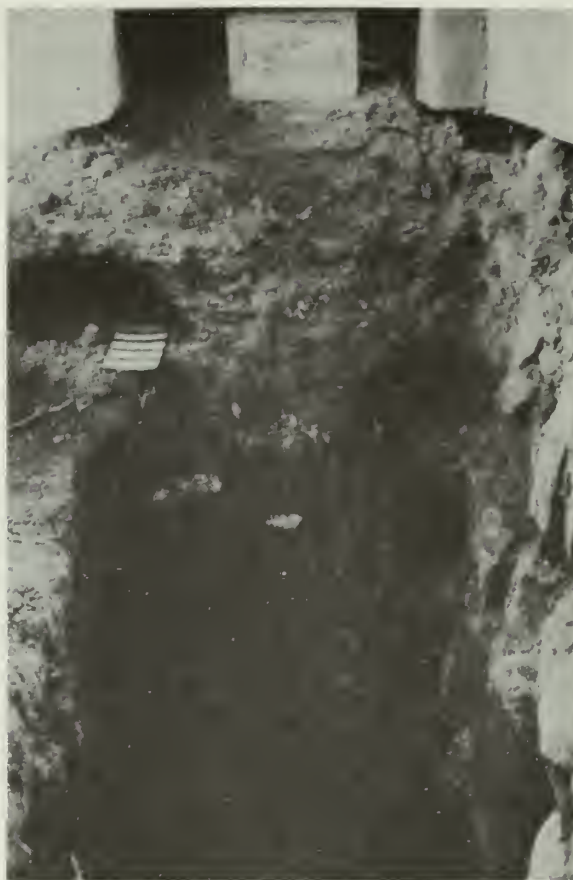
Plate 24

Test trench in N20E10. What remains of the animal burrow is seen in the upper left. The sandstone chunks are the light colored inclusions in the profile.

Since planned disturbances to this area were not to exceed 6" of grading below the present surface, and significant cultural resources had not been uncovered at 24" below the surface, further investigation of this area was limited to a 2' by 3' test trench which extended 40" below the surface (Plate 24). This test trench was located directly against the west foundation wall of the north wing, and exposed a section of that wall also to 40" below the surface. There was no builder's trench for the west foundation in this area. A soil change occurred at about 30" below the surface. At this point, naturally occurring red clay and yellow sandstone conglomerate replaced the gravelly red clay and large rocks. This change from a natural deposit to the rock and gravel filled red clay must mark the transition from original grade to fill deposits at the west side of the north wing. However, if 30" below grade represents an historic occupation level of any duration, it is disturbing that the surface of the natural red clay and sandstone conglomerate was not more clearly defined by some accumulation of cultural debris. Just by chance, the location and size of the test pit may account for the lack of cultural debris between these two deposits. It is also possible that deposition of the gravelly red clay and large rocks disturbed the former surface. Cotter's archeological investigation of the north foundation indicated that existing grade on the north side of the north wing was only several inches above original grade (1958b:3). This dichotomy in original grade at the north and west sides of the house is puzzling. However, the existence of original grade 30" below the surface at the west side of the north wing is supported by other archeological evidence. Most significant to this interpretation is the fact that there was no builder's trench for Wall 2 and it was resting on the same gravelly red clay that buried the wall to a level just beneath the porch floorboards. The gravelly red clay, large rocks, and several boulders found above the sandstone and red clay conglomerate must be fill deposited c. 1867 in conjunction with the construction of the 20' north porch addition (Plate 25). Wall 2 was a shallow (10" deep), haphazard construction of field stones reinforced by thin, grey roofing slates and brick rubble (Fig. 8). The clay and gravel which buried this wall was probably deposited to increase the stability of the wall. It is very doubtful that the boulders supporting the sleepers and the numerous large rocks removed from the first 18" of the red clay,

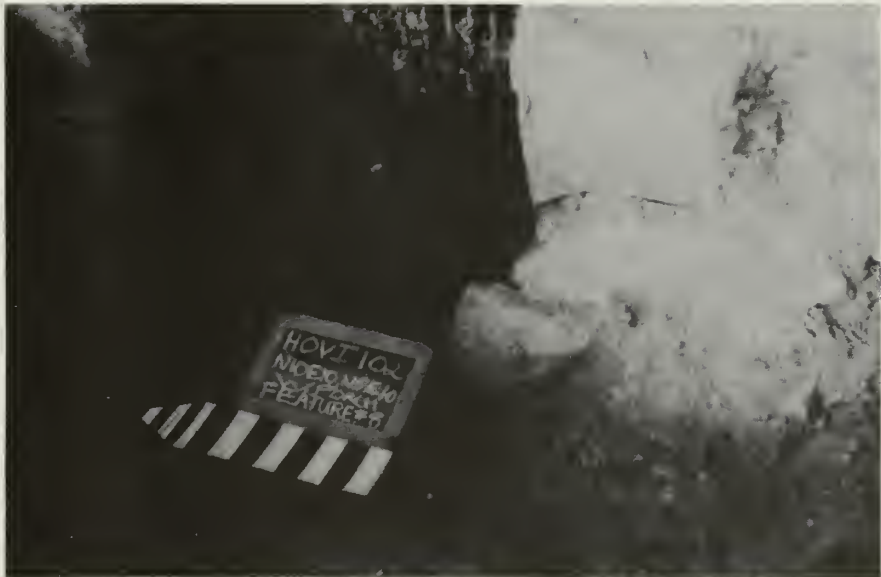
Plate 26

Vent in west wall of north wing after removal of soil and rock fill. Remnant of stone window well is to the right and slightly above the photo board. Photo board is resting in trace of well left by missing stones.

1958a:1). After removing the light brown powdery surface deposit, the thin layer of yellow clay and the hard packed, mottled orange clay and rocks which buried the vent on the outside, it was discovered that a stone window well had originally protected the vent (Plate 26). Part of the south wall of the window well was still extant and mortar on the surface of the upper stone indicated it had originally been at least three courses high. A trace of the west and north sides of the stone window well was visible as a rectangular depression northwest of the vent. The active use of this window well was apparently associated with the uneven surface defined by the small, mortar covered stones embedded in the reddish-orange clay. Since original grade, which appears to be the surface of the sandstone and red clay conglomerate, occurs 10" to 12" lower here (42" below grade) than at the northwest corner of the north wing, the base of the vent must have been 15" to 16" above original grade immediately following construction of the west wall of the north wing. Therefore, it must have been necessary to mound additional soil beneath the vent in order to construct the window well.

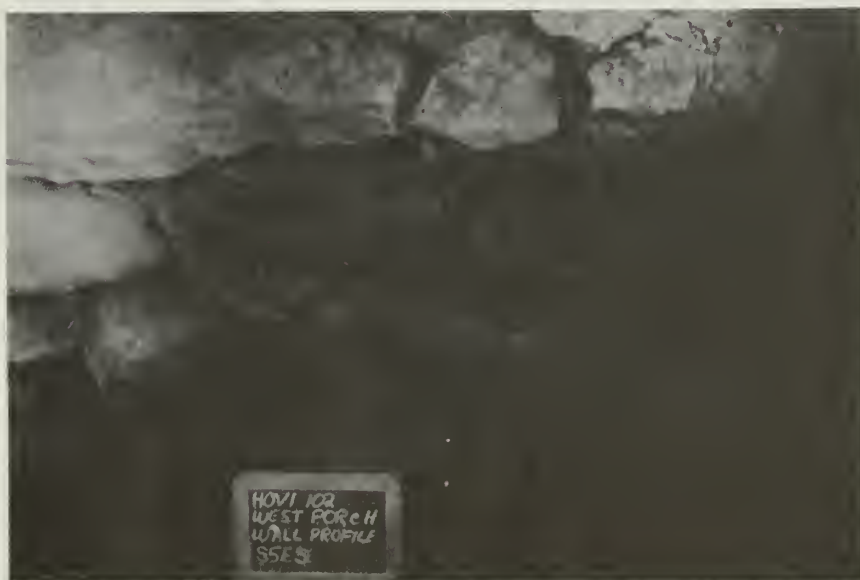
Plate 32

Detail of Wall 5, looking south. Wall continues west for an undetermined distance.

The most significant discoveries in these units included the termination of the thickened foundation at the juncture of the two wings (Plate 30); a previously undocumented wall (Wall 5) (Plates 31 and 32);

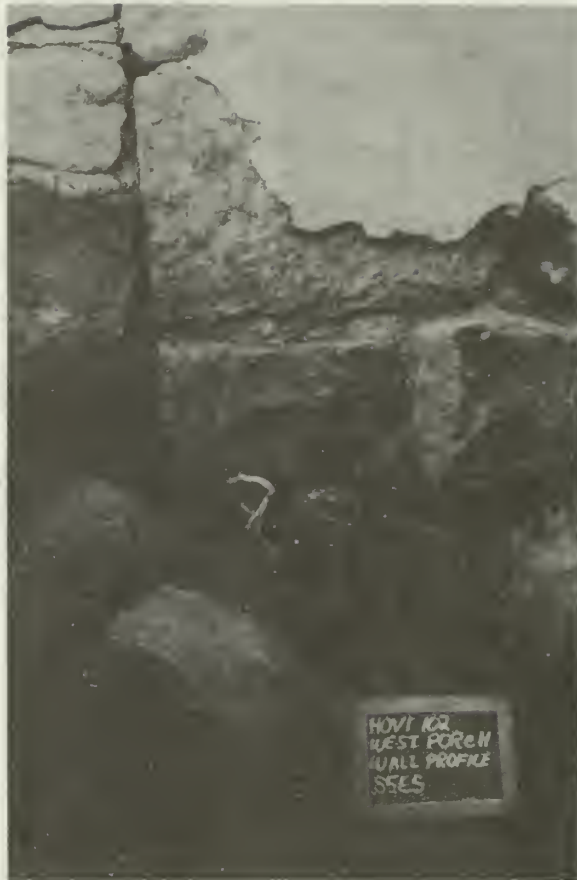
Plate 33
Original portion of Wall 4 meets C. 1867-70
west extension at upper left of photo.

and the discovery that Porch Wall 4 is the product of two building periods, as evidenced by an abutting wall extending the original 6' porch wall another 4' to the west (Fig. 9; Plate 33).
